Manhole Inspection Summary

Manhole # S53G__007MH

Insp Date: **4/15/08 1:35 PM**

Location Address: **247 S.clinton St**

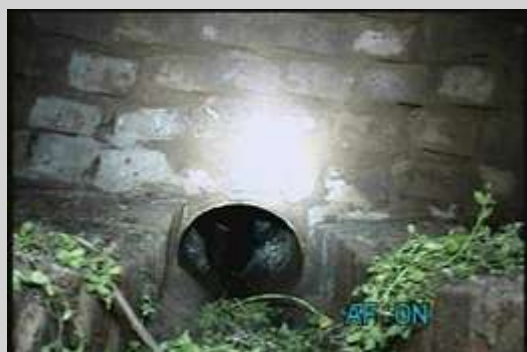
12 O'Clock Outflow

8 in. Circular Gravity Sewer
Pipe Out @ 12 O'Clock

Pipe Material: **Clay** ☐ Pipe Lined

Invert Depth: **6.80** (ft.) Flow Characteristics: **Slow**

Deposits: ☒ None ☐ Mud ☐ Sludge ☐ Debris ☐ Grease

Infiltration: **None** Pipe Seal Cond: **Unknown**

Connects To: **Manhole**

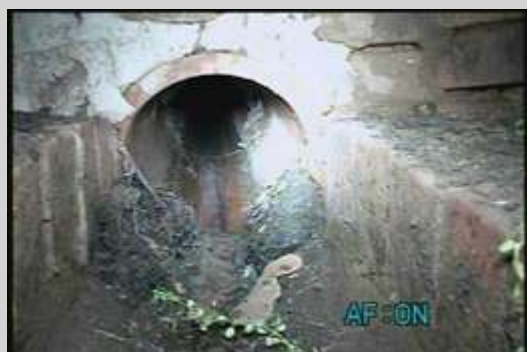
6 O'Clock Inflow

8 in. Circular Gravity Sewer
Pipe In @ 6 O'Clock

Pipe Material: **Clay** ☐ Pipe Lined

Invert Depth: **6.25** (ft.) Flow Characteristics: **Slow**

Deposits: ☒ None ☐ Mud ☐ Sludge ☐ Debris ☐ Grease

Infiltration: **None** Pipe Seal Cond: **Unknown**

Connects To: **House connection / Service line**
